PMME 2016

Failure investigations of a first stage Ni based super alloy gas turbine blade

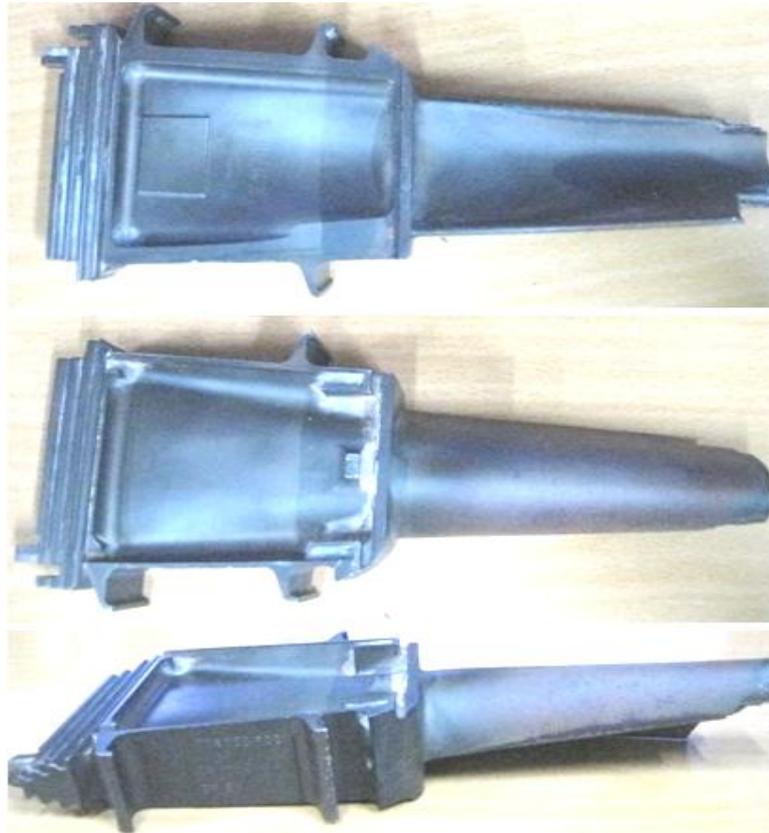
Fig. 2: Views of failed gas turbine blade (a) front view, (b) Rear view & (c) side view

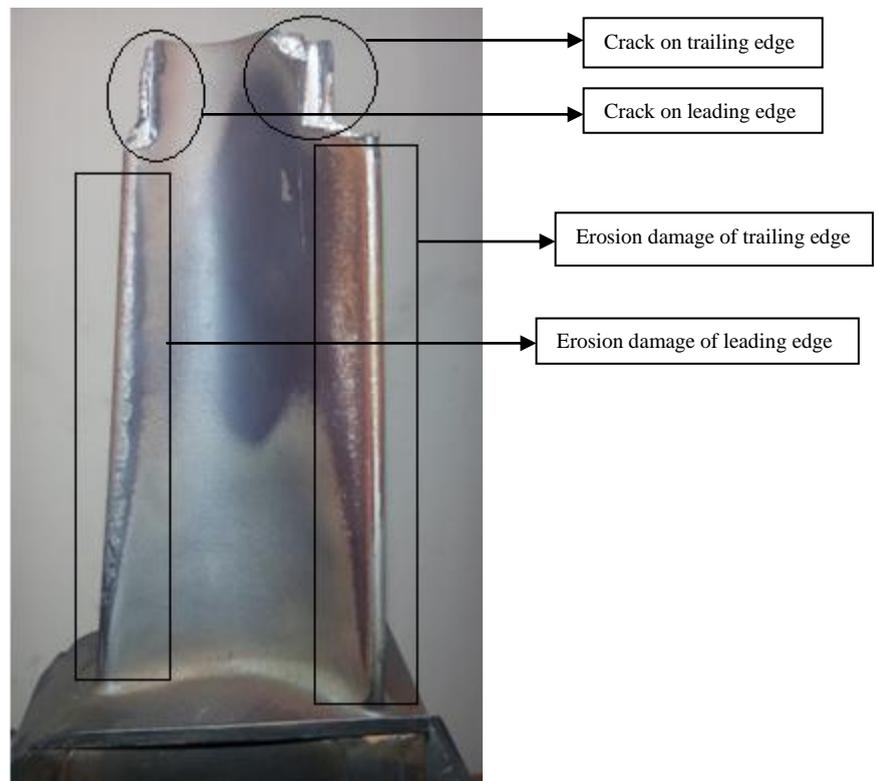
From the visual examination it is found that the failed gas turbine blade has crack on the tip of leading edge as well as on the tip of trailing edge. Both the leading edge and the trailing edge are found eroded along with the oxide scale formation in the airfoil region on both concave and convex sides.

Fig. 3: Crack and Erosion damage found on leading and trailing edge of the first stage IN738 gas turbine blade

The reddish color of blade surface is due to presence of aluminum oxide (Al_2O_3), which results due to oxidation of Al-Pt coating. The inclusions that flow in the hot gas stream are responsible for erosion of blade surface. These inclusions form oxides and impinge on the blade surface.

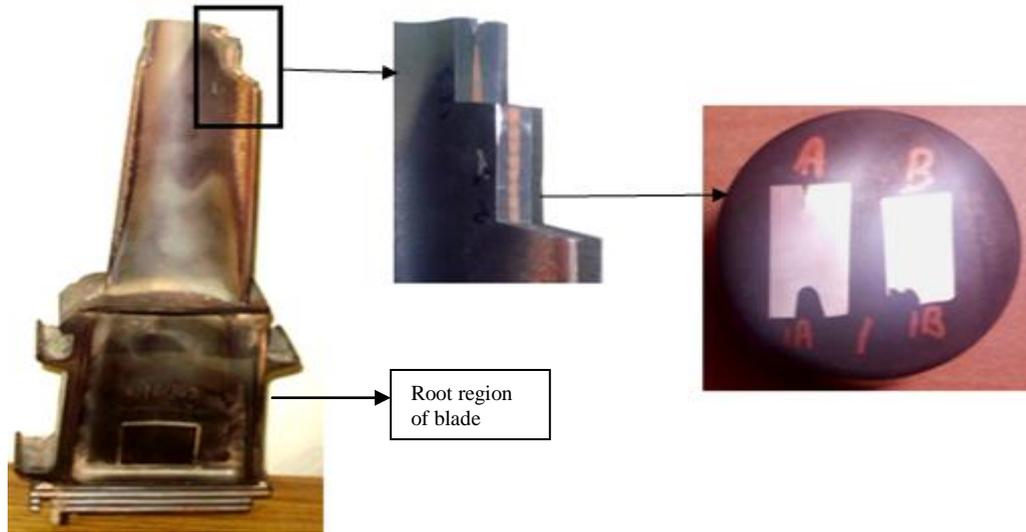
The microstructure investigation of the crack tip at the trailing edge was carried out. Two samples were cut by means of wire cutting operation over the trailing edge as shown in Fig. 4. For evaluating microstructure, a sample was prepared from the root region of the failed blade.

Fig. 4: Specimens cut from failed turbine blade

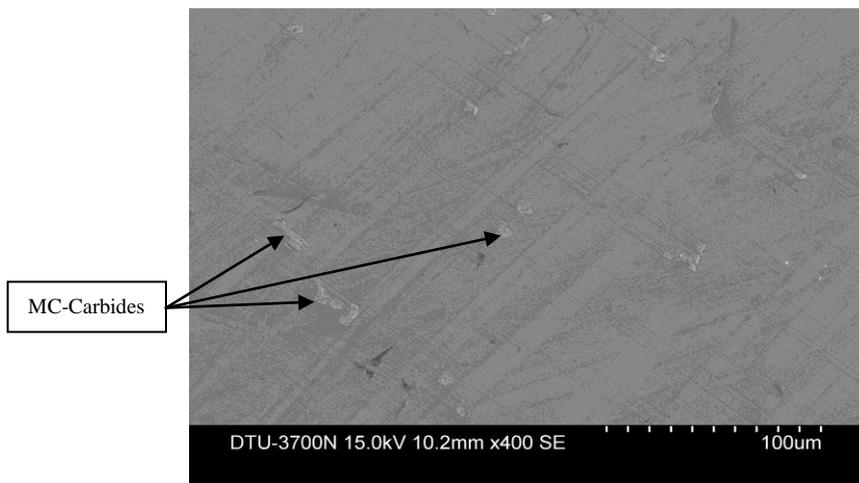
Fig. 5 shows the microstructure of the reference sample. It consists of carbides of MC precipitated on grain boundaries, grain interior and matrix. An EDS spectrum of turbine blade material is shown in Fig. 6.

Fig. 5 : MC-carbides precipitated on grain boundaries and matrix

At high temperature operation of gas turbine blade carbides of MC type transforms to carbides of $M_{23}C_6$ type.

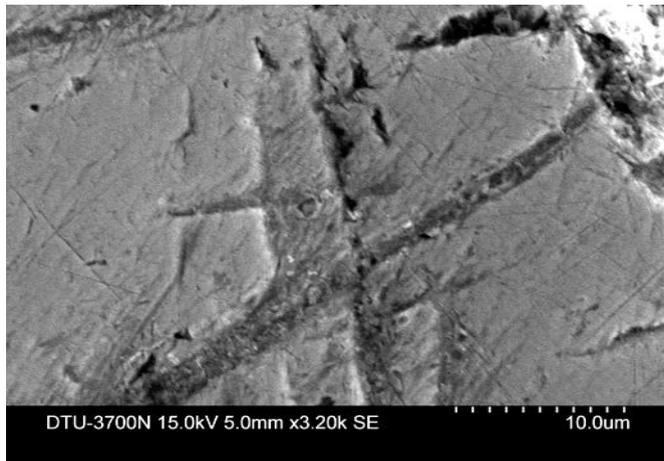
At high temperature working of turbine blade for long period results in the formation of topologically closed packed (TCP) phases as shown in Fig. 8. The mechanical properties of the blade material are degraded due to structure instability of the alloy which further results in decrease of turbine life.

Fig. 8: Topologically Closed Packed (TCP) phase of the first stage IN738 gas turbine blade after service of 1,30,000 hrs

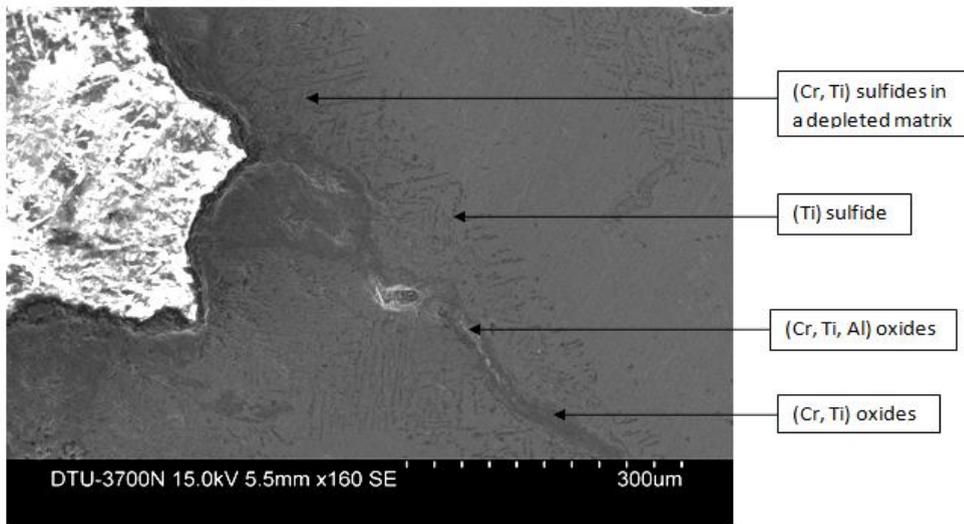
Fig. 9 shows rapid oxidation at high temperature in the presence of sodium sulfate which form by the combination of sulphur, oxygen and sodium. Sodium sulfate combine with chromium to form a mixture of salts and sulphur which is released due to the reduction of sodium sulphate. This released sulphur penetrates inward and react with chromium to form chromium sulfide in the substrate. Further, sulfides are converted to complex unstable metal oxides as corrosion proceeds and sulphur which is released penetrates deeply to form more sulfides into the substrate. An EDS spectrum confirmed the presence of corrosion products shown in Fig. 10. Fig. 11 shows X-ray diffraction pattern of sample collected from failed blade [13].

Fig. 9: Hot corrosion: subscale oxides and sulfides are visible in the substrate

SEM images obtained by Hitachi S-3700N scanning electronic microscope shows the presence of sulfides and oxides in the substrate which are the by products of hot corrosion, and Topologically Closed Packed (TCP) phase of the first stage IN738 gas turbine blade which results due to overheating. The EDX spectrum confirms hot corrosion and overheating. X-ray diffraction patterns of samples collected from failed turbine blade are also shown. There x-ray patterns are similar to IN-738 nickel based alloy found in literature.

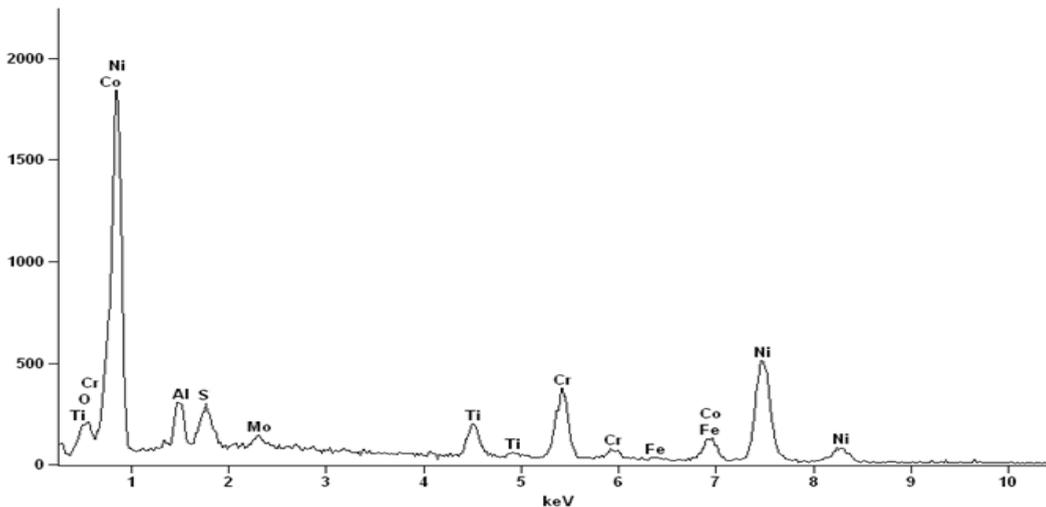
Fig. 10: The EDS spectrum of corrosion products confirm hot corrosion

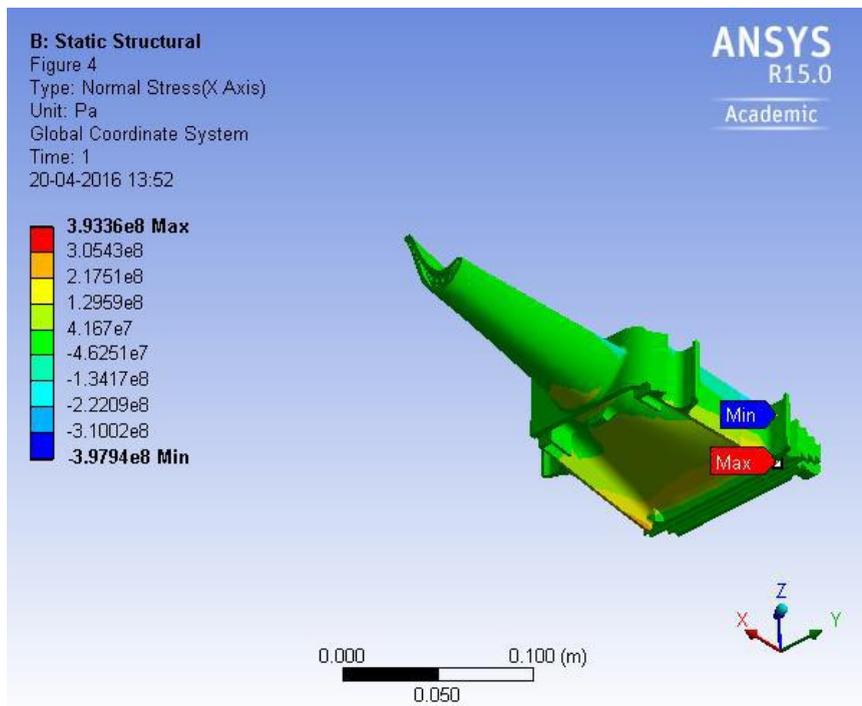
The stress of first stage IN738 gas turbine blade is evaluated by performing static structural analysis of gas turbine blade on finite element software ANSYS [10]. The maximum tensile stress found approximately 393 MPa as shown in Fig. 12.

Fig. 12: Normal stress of the first stage gas turbine blade

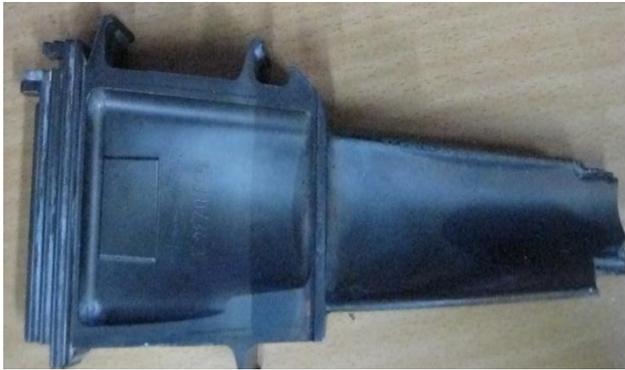
Fig. 13(a) and 13(b) shows a very good agreement between crack location at the tip of trailing edge and leading edge of the failed first stage gas turbine blade and FEM results [10].

Fig. 13(a): Failed first stage gas turbine blade

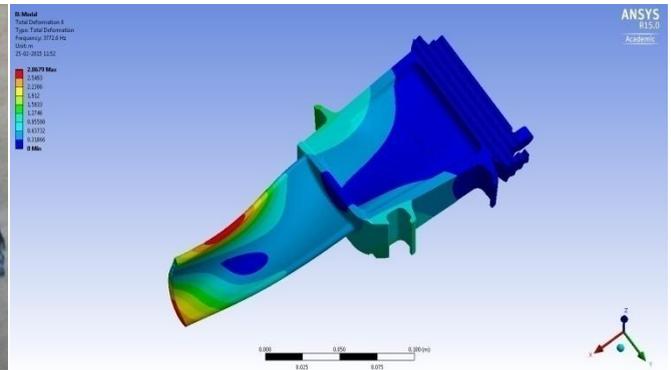
Fig. 13(b): Total deformation of the first stage gas turbine blade
