PMME 2016

Non Destructive Evaluation of A356 alloy Castings made in Sand and Granulated Blast Furnace Slag Moulds

I.Narasimha Murthy and J Babu Rao*

Dept of Metallurgical Engg, Andhra University, Visakhapatnam – 530003, India

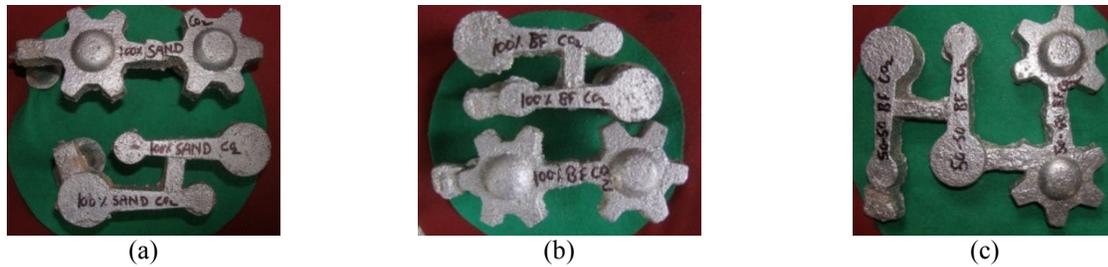
Figure 1: A356 Aluminum alloy castings before machining casted in: (a) 100% Sand mould (b) 100% GBF Slag mould (c) Mixture of 50%GBF Slag + 50% Sand mould

Al-Si alloy having a wide range of applications in the automotive and aerospace; also provides the most significant part of all shaped castings manufactured. Hence, melting and casting practice of A 356 (Al-7.5%Si) alloy castings was performed on these newly made GBF slag moulds. For this study three types of moulds were selected, namely; Type 1: 100% Silica sand; Type 2: 100% GBF slag; and Type 3: mixture of 50% GBF slag + 50% Sand. The best possible mould properties were obtained by optimum addition of sodium silicate along with a sufficient CO₂ gassing [9]. Present investigation two types of patterns namely toothed gear wheel and connecting rod were chosen and aimed to cast the same. Cope and drag as well as split pattern was used for preparing the mould with mould cavity. A356 alloy ingots of 500 grams in weight was taken in a graphite crucible and melted separately in a high temperature melting furnace at 750 °C. The molten metal was allowed to fill in the mould cavities via sprue, runner and in gates; care was taken to ensure continuous and smooth flow of the liquid metal while filling in the mould cavities. Riser was placed in the mould to ensure complete mould cavity filling. After cooling the castings were withdrawn from mould boxes and same was undergone for further quality inspection like macro and non destructive evaluation. Figure 1 shows the A356 alloy castings before machining.

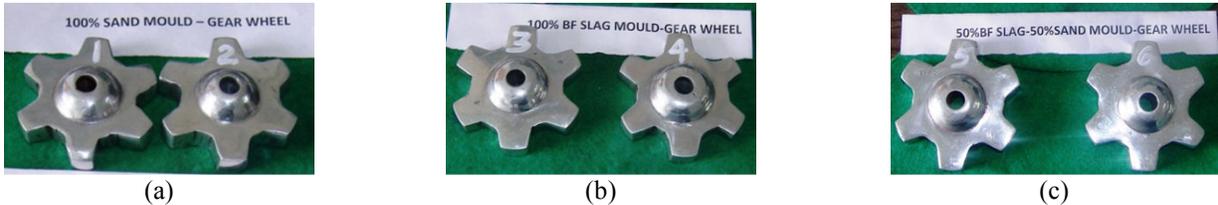
Figure 2: Visually inspected A356 alloy Gear wheel castings made in: (a) 100% Sand mould (b)100% GBF Slag mould (c) Mixture of 50% GBF Slag+50% Sand mould.

Figure 2 & 3 shows the A356 alloy gear wheel and connecting rod cast products made by sand, slag and combination of these two moulds. The visual inspection was done under sufficient light by using magnifying glass. All the components surfaces, inner & outer ring, teeth of the gear wheel and the flange of the connecting rod was examined thoroughly for possible presence of any surface defects, size and shape distortions etc. Results reveal that no such defects were observed in any of the cast products; it was also true even after machining of the components. The cast products dimensional accuracy was measured and same was compared with the respective wooden patterns. It was found that the dimensional stability was decent and accurate after giving machining allowance. It was true for both the products. Hence, it can be conclude that slag mould cast products shows on par with sand castings.
