PMME 2016

Failure investigations of a first stage Ni based super alloy gas turbine blade

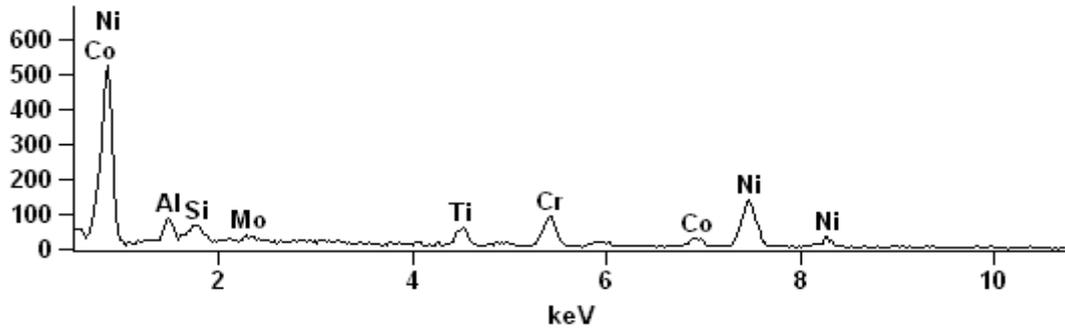
Fig. 5 shows the microstructure of the reference sample. It consists of carbides of MC precipitated on grain boundaries, grain interior and matrix. An EDS spectrum of turbine blade material is shown in Fig. 6.

Fig. 6: An EDS spectrum of reference sample of turbine blade

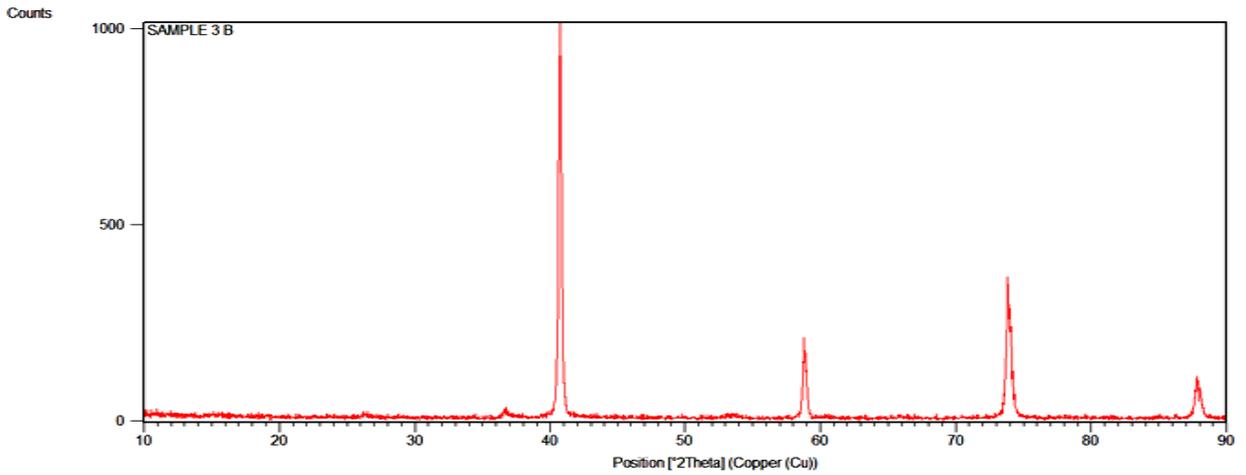
Fig. 7 shows X-ray diffraction pattern of reference sample of turbine blade [13].

Fig. 7: X-ray diffraction pattern of reference sample of turbine blade

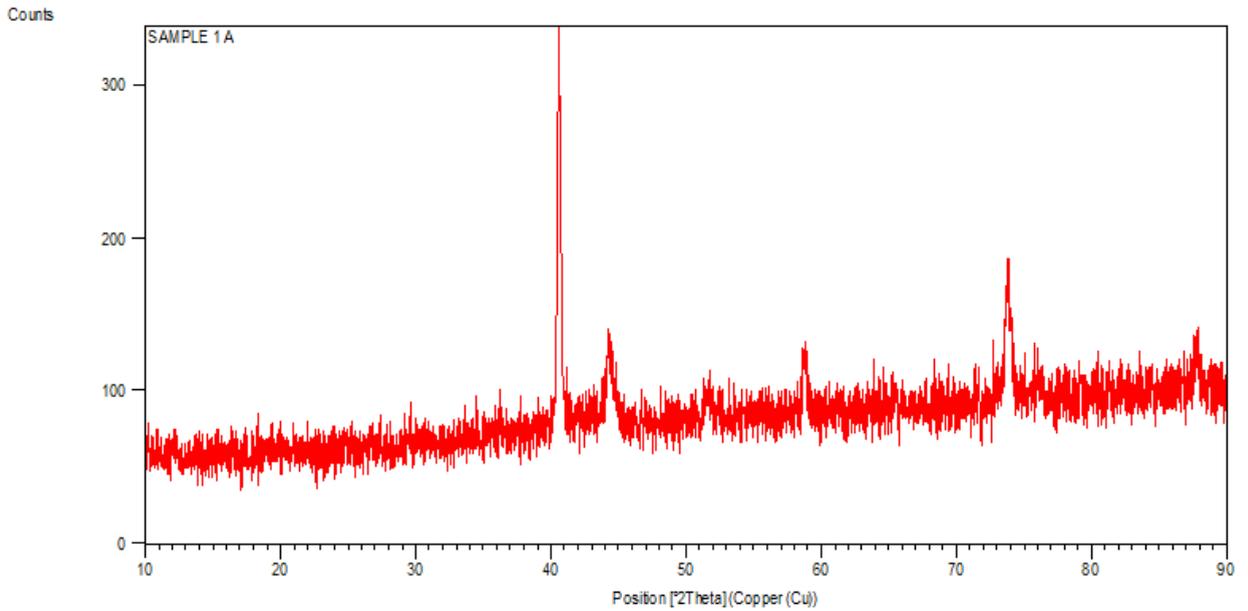
Fig. 9 shows rapid oxidation at high temperature in the presence of sodium sulfate which form by the combination of sulphur, oxygen and sodium. Sodium sulfate combine with chromium to form a mixture of salts and sulphur which is released due to the reduction of sodium sulphate. This released sulphur penetrates inward and react with chromium to form chromium sulfide in the substrate. Further, sulfides are converted to complex unstable metal oxides as corrosion proceeds and sulphur which is released penetrates deeply to form more sulfides into the substrate. An EDS spectrum confirmed the presence of corrosion products shown in Fig. 10. Fig. 11 shows X-ray diffraction pattern of sample collected from failed blade [13].

Fig. 11: X-ray diffraction pattern of failed blade
